GOOD SERVICE PRACTICES FOR ROOM AIR-CONDITIONERS

HPMP PHASE-OUT MANAGEMENT PLAN : SERVICING SECTOR

A Project of the Ozone Cell, Ministry of Environment & Forests (MoEF), Government of India in co-operation with the Government of Germany represented by Deutsche Gesellschaft für Internationale Zusammenarbeit (GIZ) GmbH and United Nations Environment Programme (UNEP)

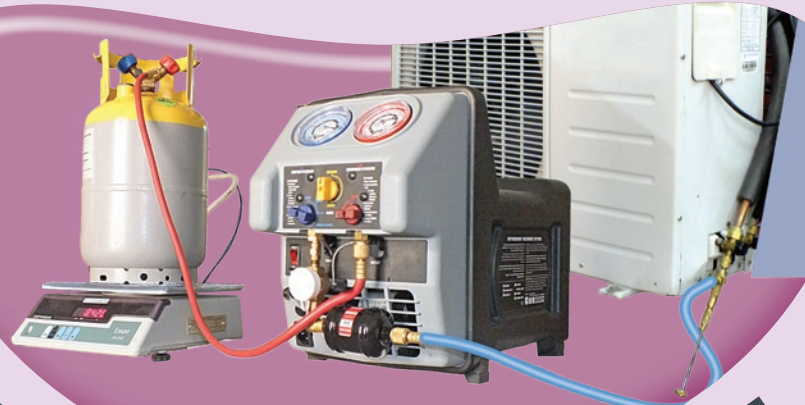
RECOVERY OF REFRIGERANT FROM SYSTEM FOR REUSE IN THE SAME SYSTEM

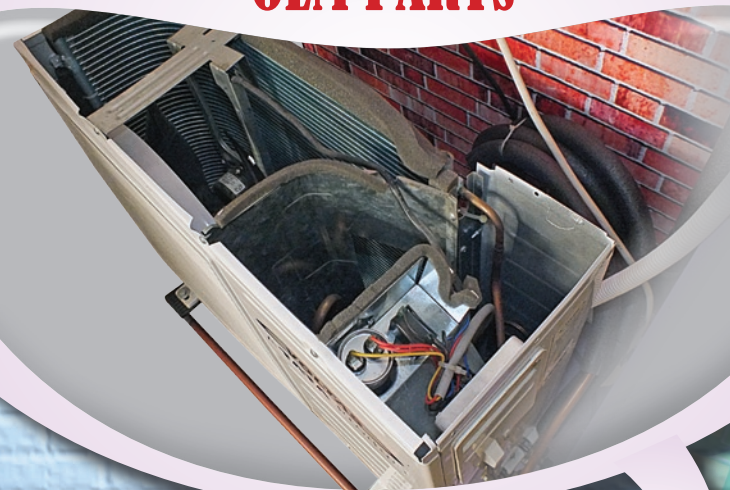
REPAIR/REPLACE DEFECTIVE PARTS WITH OEM PARTS

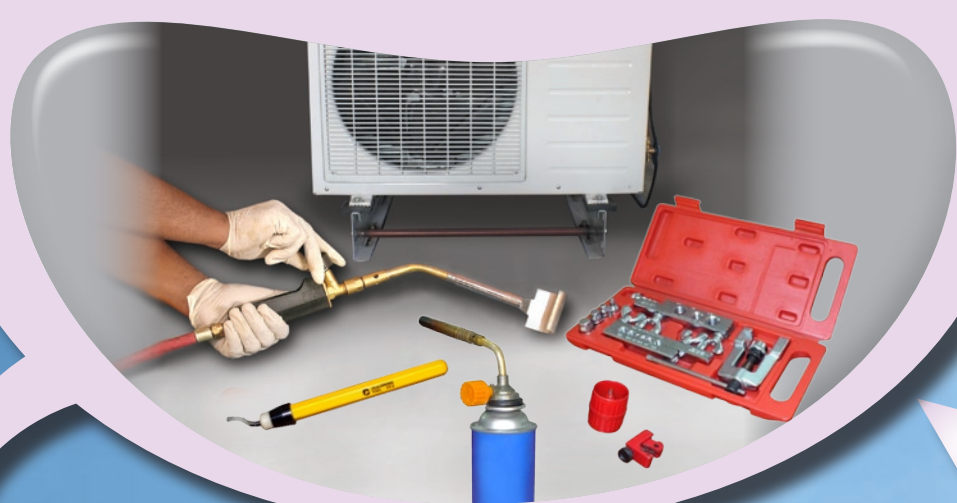
PROPER BRAZING &/OR FLARING

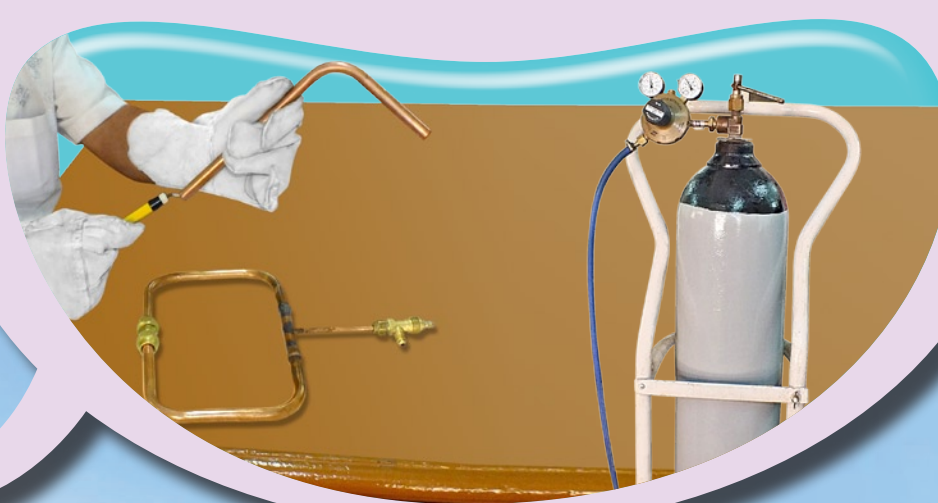
CLEANING/ POLISHING AND FLUSHING WITH OXYGEN FREE DRY NITROGEN

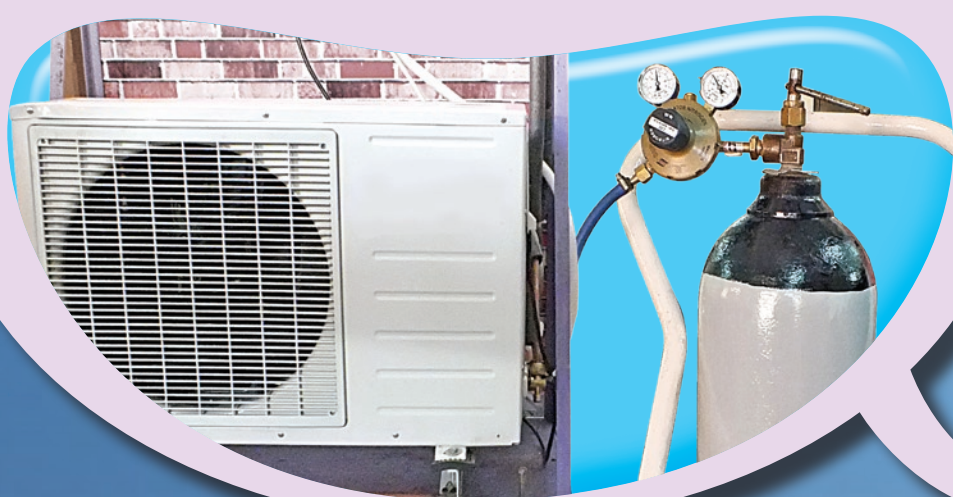
LEAK/ PRESSURE TESTING WITH OXYGEN FREE DRY NITROGEN

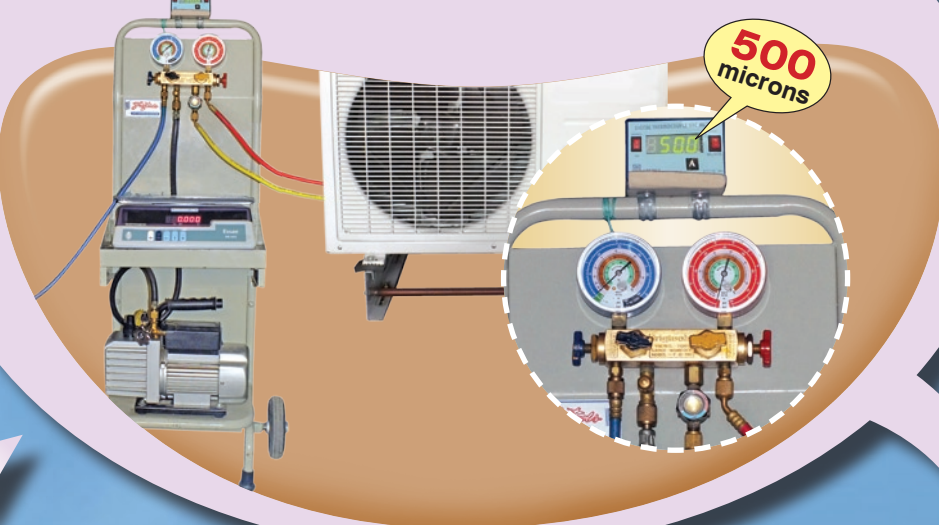
EVACUATION AND VACUUM HOLDING

Our aim
500 microns

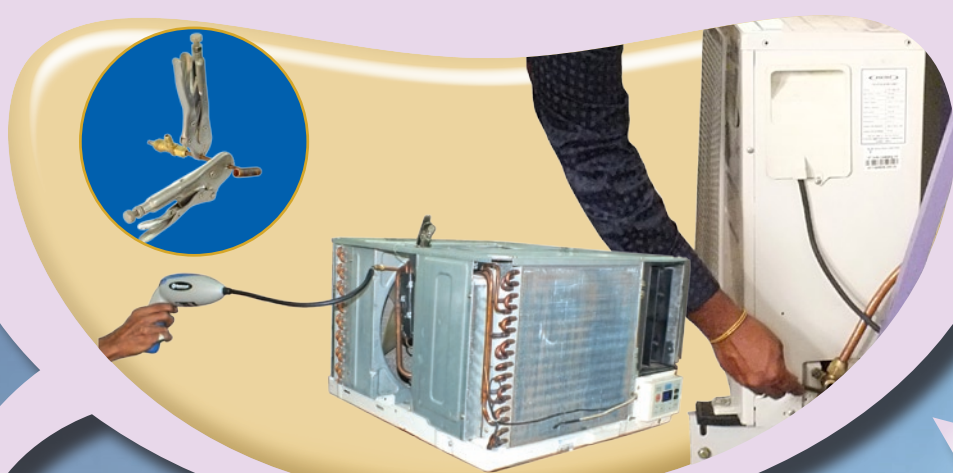
SEALING PROCESS TUBE/CLOSING VALVES

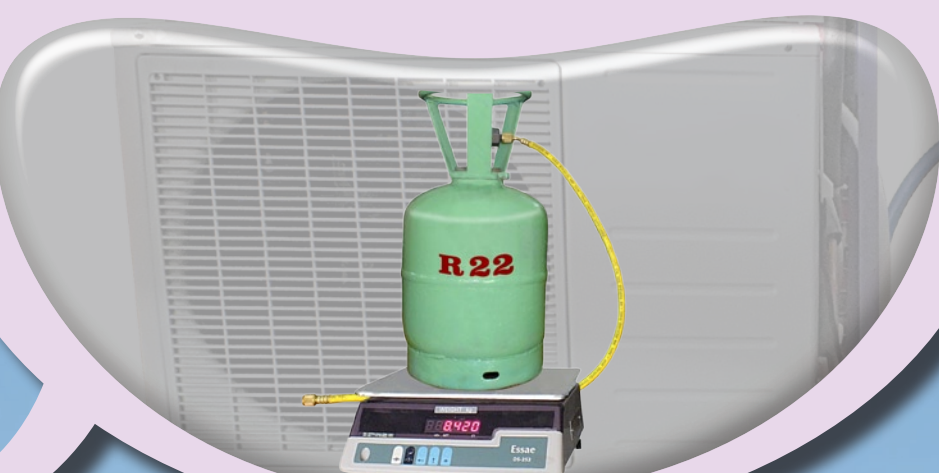
REFRIGERANT CHARGING BY WEIGHT

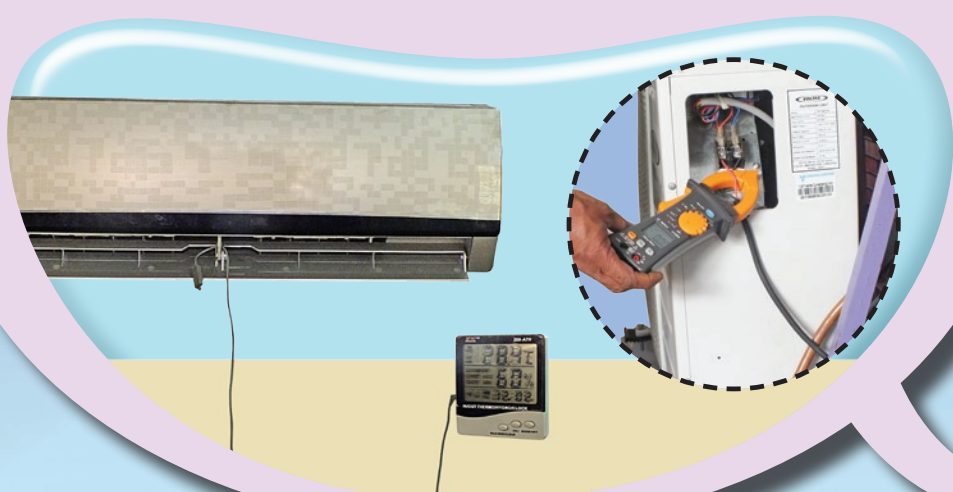
CHECK FOR PROPER OPERATION AND FINAL LEAK CHECK

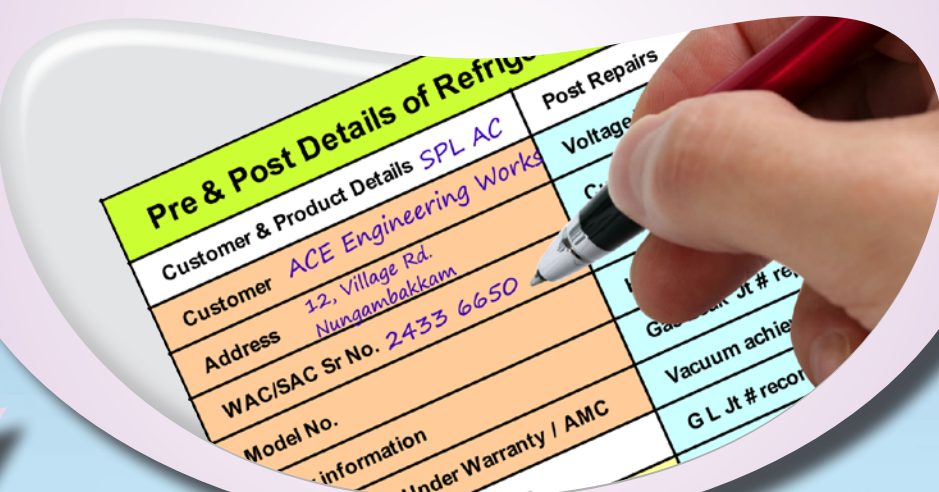
RECORD DETAILS OF WORK DONE
